Product/maintenance information No. 2015-1

Automatic De-airing

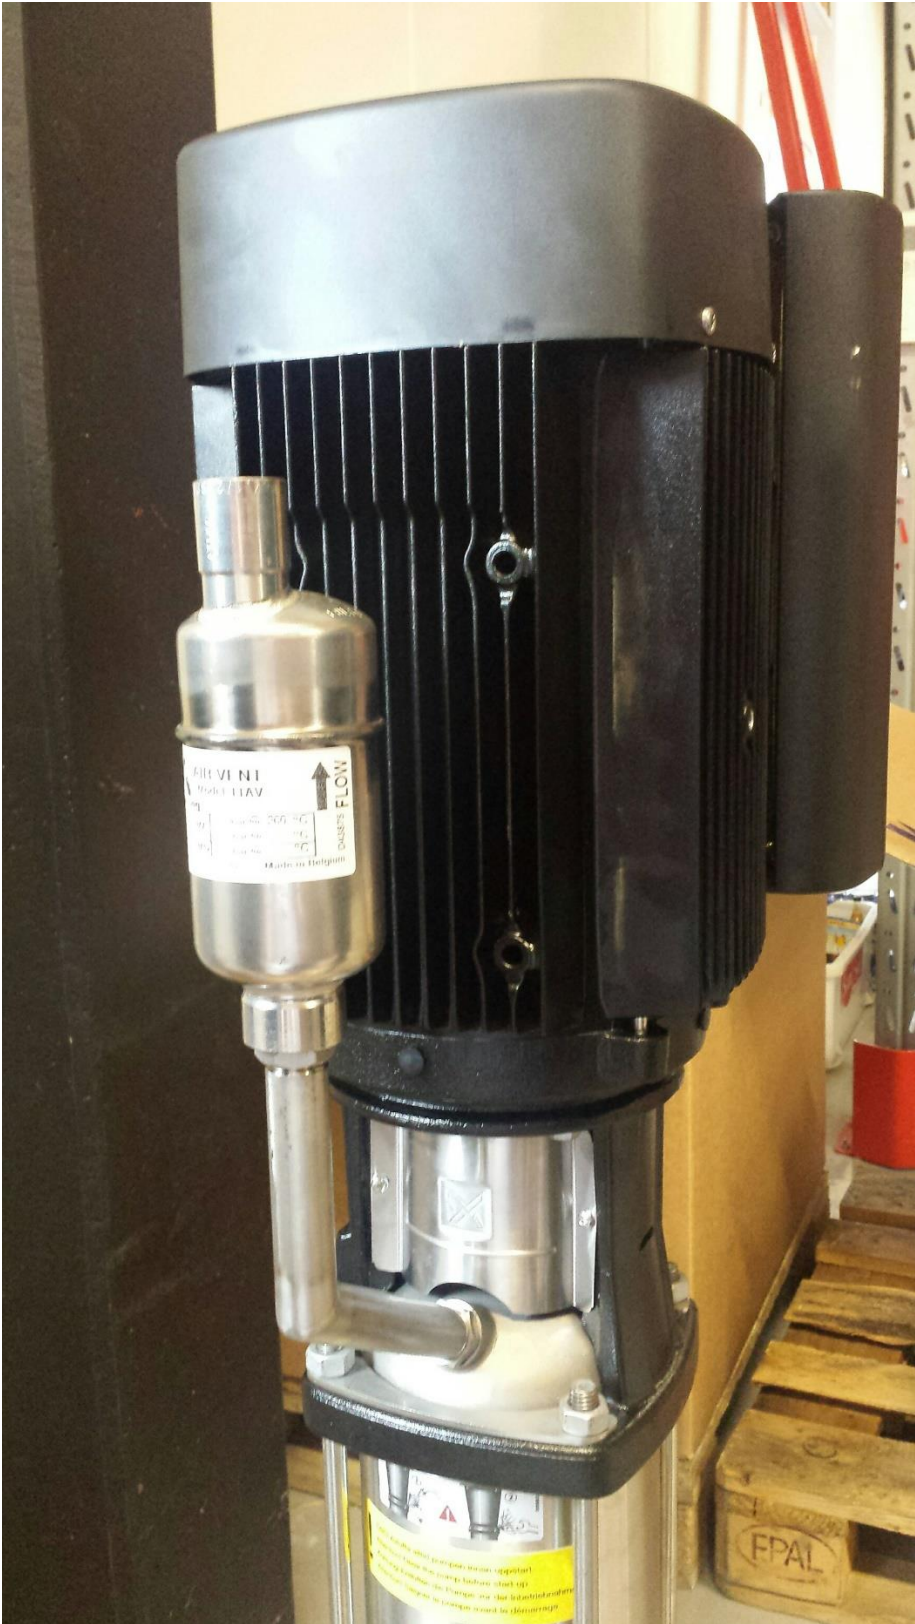
Picture

When supplying high volumes of water to our units, customer have had problems with air coming in with the inlet water and this air has been trapped in the top of the pump causing the shaft seal to break due to no water lubrication. This has been a problem especially on the 40 bar pumps.

From January 2015 all units in the 40 bar range (excl CB) has an automatic de-airing valve installed on each pump. It will not affect the price and it will be delivered as standard. Article number is clearly stated in the manual.
